Scope – Inspection for Insurances Purposes

General Description

This Vancouver 274 cutter rigged sloop is a coastal yacht with a single diesel auxiliary engine with standard shaft propulsion and fixed blade propeller. The hull design is full displacement with long encapsulated ballast keel and skeg supported transom mounted rudder.

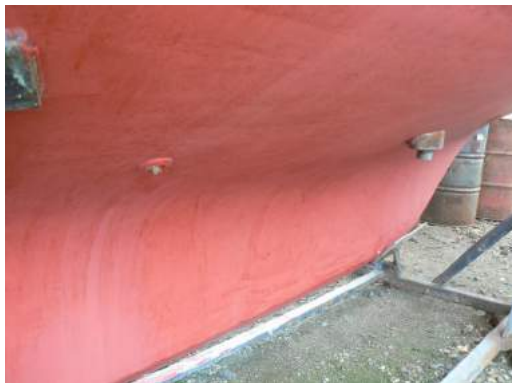
Encapsulated ballast keel revealed no faults

Encapsulated ballast keel

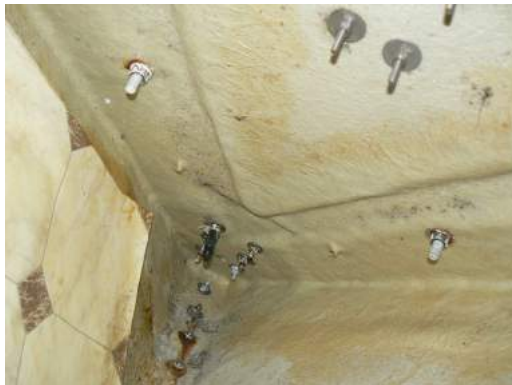
The superstructure / hull biscuit-tin bonding / connection with encapsulated through section bolts

Through deck fittings where seen in the chain locker appear to be in good order

1 Through deck fittings and hull / deck bonding

- Monitor hull condition at least every two - three years

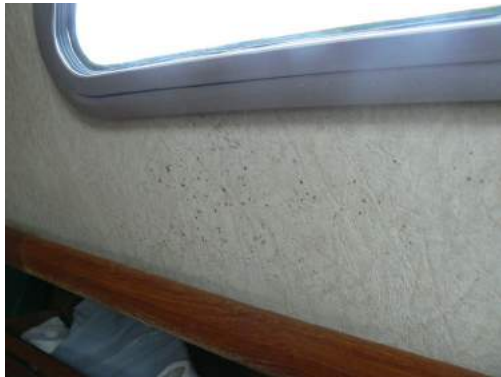
The internal side linings beneath the starboard saloon portlights gave high moisture readings on the Tramex meter, indicating possible portlight leaks.

1 High moisture content beneath the starboard saloon portlights

- Remove, re-seal and refit starboard saloon portlights

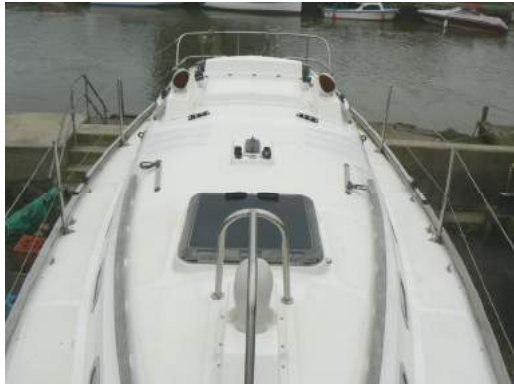
The guard wires need to be tightened and the cord / line used replaced

1 View of deck rails / stanchions etc

- General maintenance / tighten & replace guard wire lines

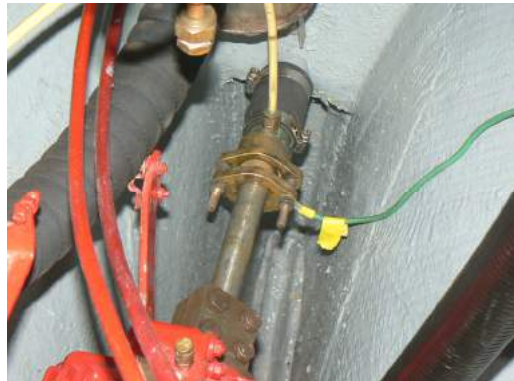
1 Stern log / packing gland with earthing strap and greaser

- Fit two J clips to all piping

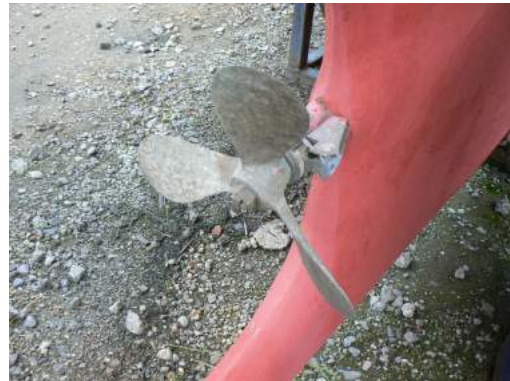
2 Propeller with rope cutter

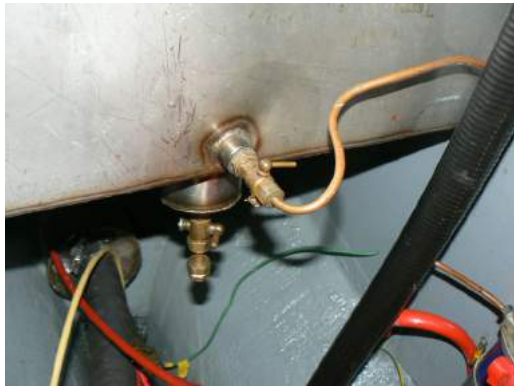
1 Fuel supply / isolation valve

- Per attached Appendix A

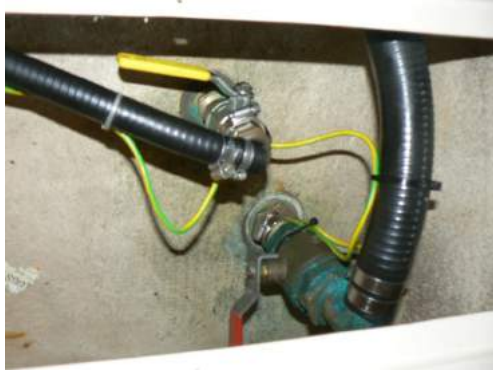
Engine :	1x seacock ball valve 1x J clip security	Operation:	OK
Amidships	2x seacock ball valve	Operation:	OK
Forward:	1x ball valve	Operation:	OK
Comment:	Clean installation

1 View of 2x seacocks amidships

- Secure all seacock piping with twin J clips throughout

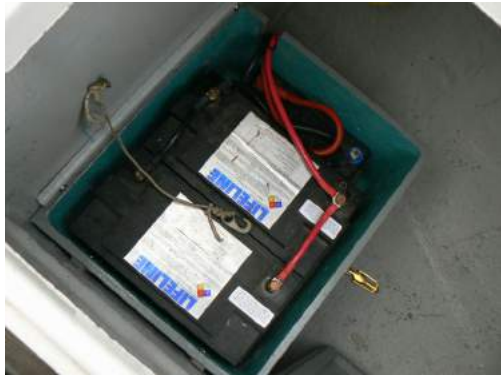
1 View of 2x 12v batteries

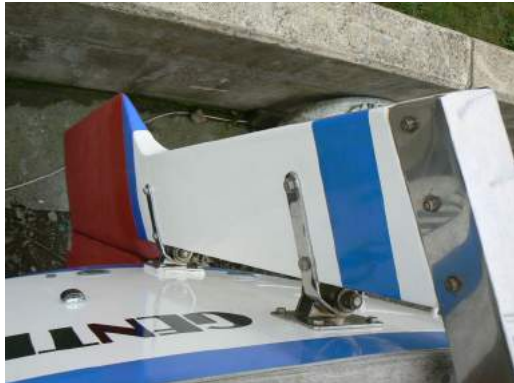
1 Transom mounted rudder with stainless steel pintles

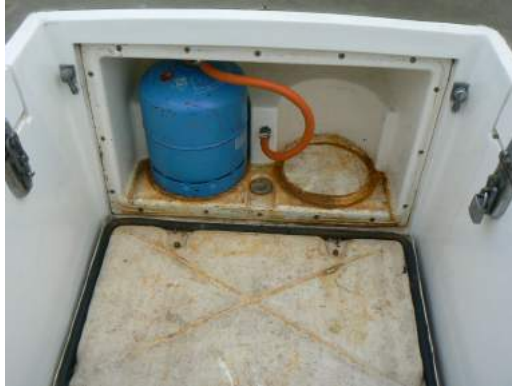
1 LPG cylinder stowage in aft cockpit

- Per Appendix B
- Add isolation valve to cooker LPG hose supply
