**Report for Insurance Purposes**

**# 01396-18**

**Inspect on the** 26 March 2018  
**the** Vancouver 274 Cutter Rigged Sloop  
**at** \_\_\_\_\_  
**Purpose** Inspection for Insurance Purpose  
**Report ref** # 01396-18

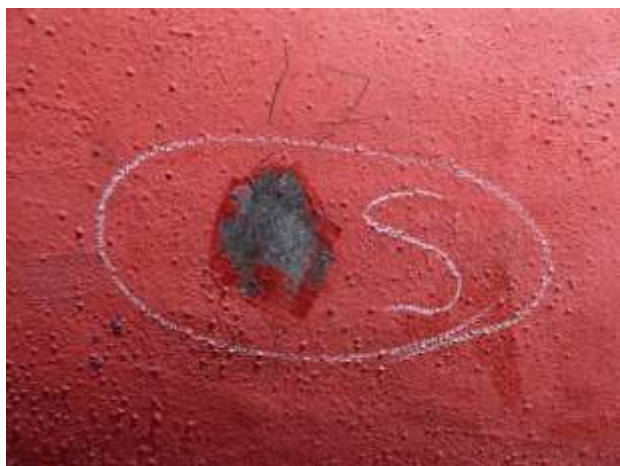
#1

**In random (sample) scraping areas** (gel coat) moisture meter readings were taken and returned medium to high readings averaging 15% - 21% indicating that the underlying substrate has absorbed some moisture. This is not unusual for a vessel of this vintage.

This meter reading translates to moisture content in the GRP substrate sample scraping areas of around 1.5% - 2.1%. Additional meter readings were taken around the hull bottom with similar moisture results

Sample Area

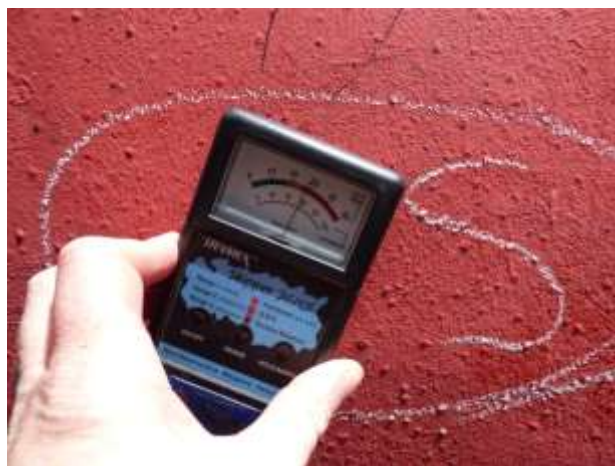
# 2

Typical Meter Reading
