## Condition Survey

On Easticks Yacht 'Swallowtail'

**Name of vessel:** Swallowtail. Sail number: 222.

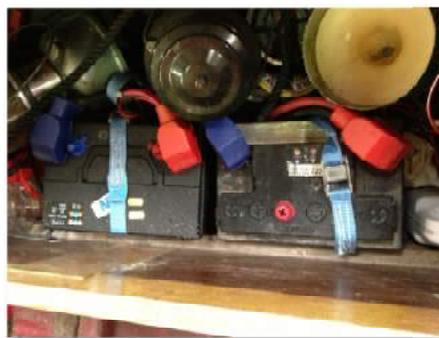
There were two heavy duty lead acid type batteries which were adequately secured against any movement and their terminals were covered. The area of installation was considered adequately ventilated, and the batteries appeared to be in reasonably good condition.

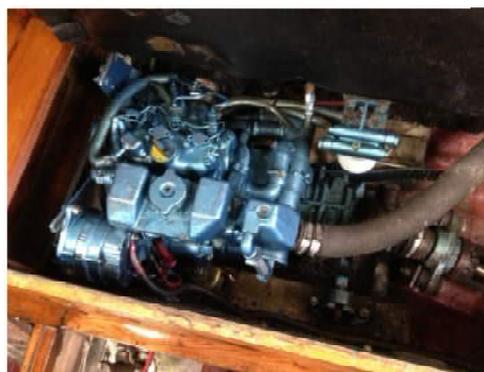
A visual inspection of the engine, filters and related connections showed no signs of abuse and a good maintenance regime became apparent. The stringers that support the engine mounts were cored fibre glass and in turn they were secured to the hull and appeared to be free of stress.

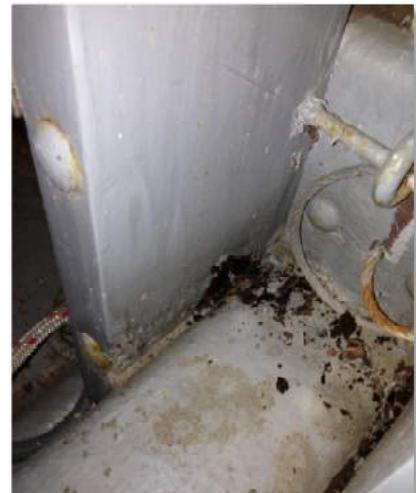
The mast was bilge stepped and support was provided by an oakwood tabernacle. There was an area of timber deterioration noted at the base of the tabernacle and this should not be overlooked. The two 'thru bolts' at the lowest position should also be replaced.

- Repair and restore the base of the tabernacle to its original condition. This will involve removing all degraded wood material and filling with epoxy fibreglass. Reinforcing with a new base block and fibreglass over to allow water to run off and not to accumulate. Replace the through bolts at the base of the tabernacle.
- Replace the bent bottle screw. (Starboard aft chain plate).

1. Repair and restore the base of the tabernacle to its original condition. This will involve removing all degraded wood material and filling with epoxy fibreglass. Reinforcing with a new base block and fibreglass over to allow water to run off and not to accumulate. Replace the through bolts at the base of the tabernacle.

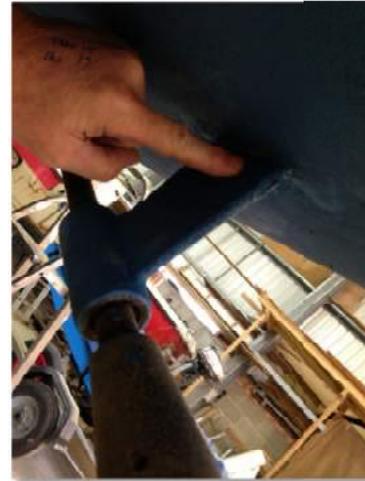
The P brackets securing was slightly loose and I recommend this is not overlooked. The rubber cutlass bearing was firm and tight.

2. Replace the bent bottle screw. (Starboard aft chain plate).
3. Secure the 'P' bracket that supports the propeller shaft so as to prevent any movement. This will involve either drying out the joint and running around an epoxy fillet on the exterior or removing the encapsulated bracket internally and re-fitting.
