**Report for Insurance Purposes**

**# 01396-18**

**Inspect on the** 26 March 2018  
**the** Vancouver 274 Cutter Rigged Sloop  
**at** \_\_\_\_\_  
**Purpose** Inspection for Insurance Purpose  
**Report ref** # 01396-18

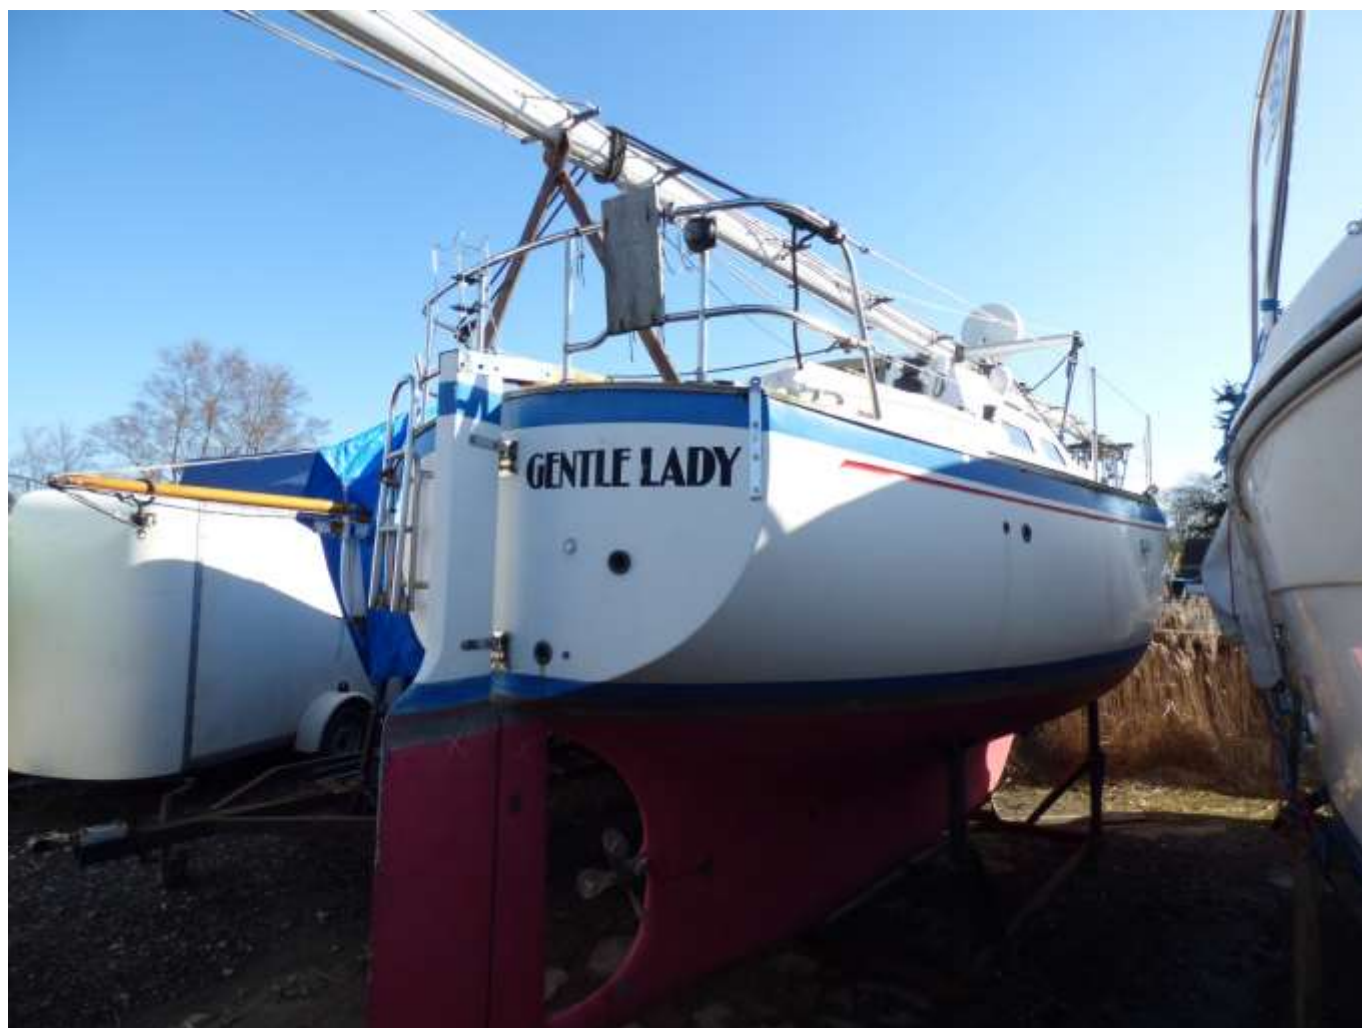
The underwater sections have been anti-fouled red and are in reasonable paint condition. The hull topsides are white original shell gel coat with white original shell gel coat superstructure and raised non slip deck tread areas. The hull bottom and topsides are clean and well presented

Weather Conditions: Dry and Sunny
