## Condition Survey

On Easticks Yacht 'Swallowtail'

**Name of vessel:** Swallowtail. Sail number: 222.

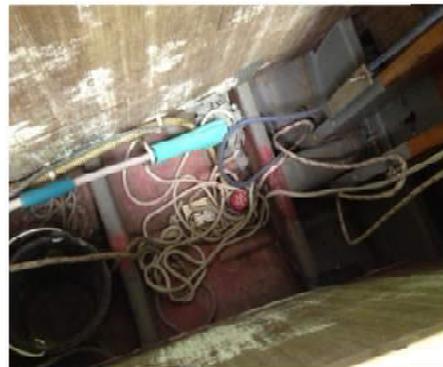
The electric bilge pump was installed below the tabernacle and was visibly inspected and found in good order and although it was not possible to survey all the associated pipework in detail such as I was able to inspect appeared satisfactory with the connections and worm drives clamps in a serviceable condition.

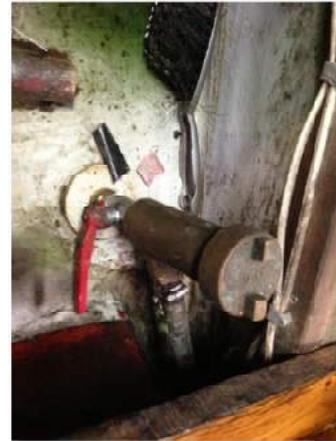
The skin fittings were not drawn for inspection but were examined in situ externally by hammer and scrape testing and were found in a good condition with no obvious defects. The engines cooling through hull fitting was fitted with a ball valve on the inside of the hull and this was examined without opening up for seizure, position and corrosion. The valve appeared to be in good order, accessible and satisfactorily operational with no signs of water ingress in way of the seals or gland.

Although it was not possible to survey all the associated pipework in detail such as I was able to inspect appeared satisfactory with the connections and worm drives clamps in a serviceable condition.
